Trusting Is Good – Monitoring Is Better! Quality assurance with MMVision

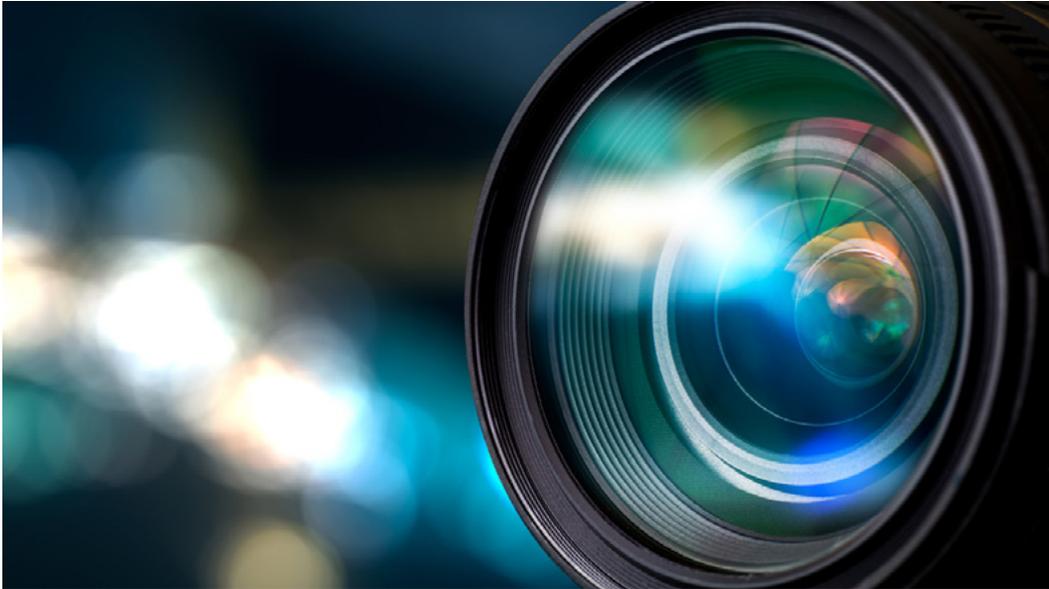
following case separation from the gathering tray, a high-resolution camera uses image matching to check the positioning of the book case. At the start of the order, the first two book cases that are separated from the gathering tray are used as a reference to match the images. The image captured by the camera is displayed to the operator in real time on the separate MMVision monitor alongside the Diamant MC tele-commander.

If an error occurs and a book case is identified as being positioned incorrectly, the machine will stop and the monitor will display a clear error message for the operator. The case can be removed from the case forming station by the operator or moved into the correct position.

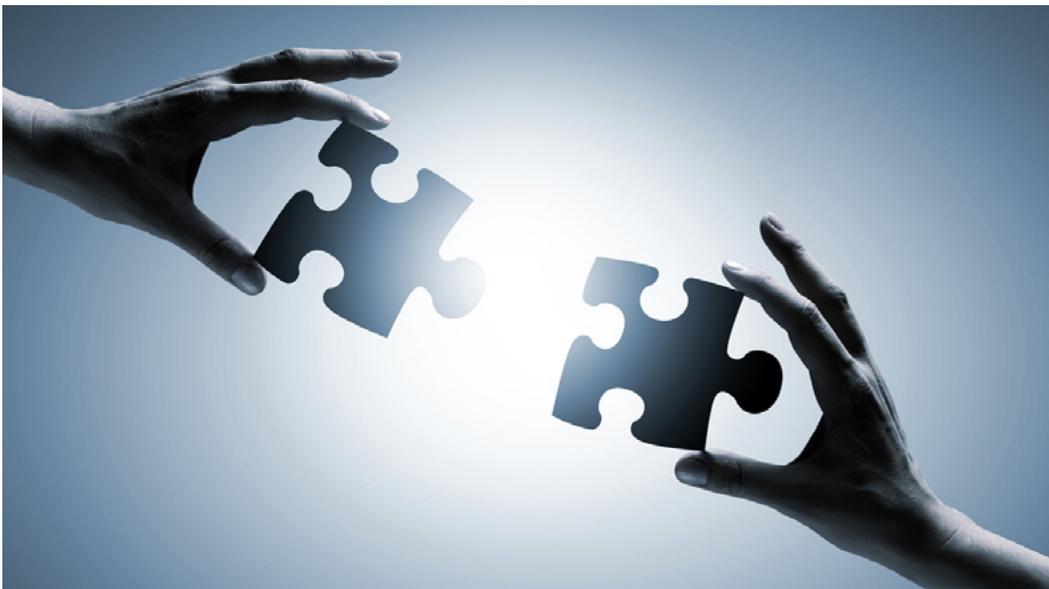
With MMVision, the correct position of the book block can also be monitored and secured in the infeed area of the Diamant MC bookline. Here, too, the high-resolution camera monitors the process, recognizing the head markings of the block on the side fold of the liner by matching the images. If the marking is not recognized, the conveyor belt stops, the bookline continues producing and the operator can remove or correct the block. During this process, the block position of each individual block is displayed in real time on the MMVision monitor.

The MMVision control system can be equipped with as many as five cameras in various places on the production line. All images from the cameras placed on the production line are displayed on the operator's monitor, making it possible to respond quickly or make corrections, if necessary, and avoid production mistakes.
